# ASSISTING YOUR BARRISTER - ACCIDENT RECONSTRUCTION CASE STUDY

John Boyd, [jboyd@orange.nsw.gov.au](mailto:jboyd@orange.nsw.gov.au)  
Acting Director Technical Service , Orange City Council,  
NSW, Australia

This case study discusses how a defence was developed against a civil claim by assessing seven year old evidence to reconstruct the circumstances of a motor vehicle accident. Our reconstruction of events differed markedly from the account presented by the investigating police officer and that proposed by the plaintiff.

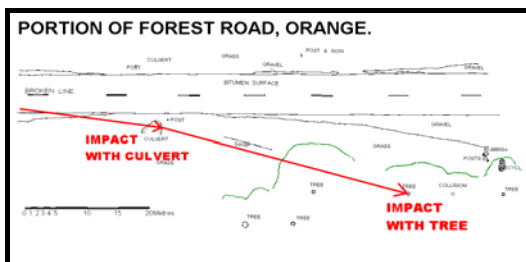
Diagram 1

**Diagram 1** gives a general overview of the situation as it existed at the time of the accident. This diagram also shows

the approximate path of the vehicle as it left the road and passed through a drain extending from a pipe culvert to the eventual point of impact with the tree. Wet weather conditions prevailed at the time of the accident.

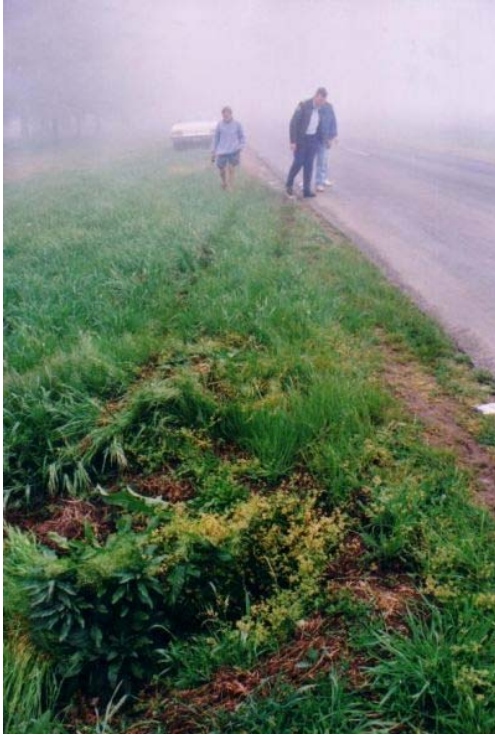
Photo 1

**Photo 1** shows the path where the vehicle left the road. On face value this photograph appears to show the vehicle driving straight at an angle of approximately  $30^\circ$ , directly into the culvert drain.

Thus, it appeared to me that the officer was simply using photos to interpret the accident rather than actual measurements or facts. This prompted me to investigate **Photo 1** in much more detail.

Looking further it appeared that in comparison to the officer's height the wheel tracks were relatively narrow (even for a Mini). Given the officer's foot was on one of the wheel tracks I thought it reasonable to be able to estimate dimensions at this distance from the camera. Based on the assumption that the officer was around 1.75m tall (his height was observed in Court) the distance between the tracks scaled at approximately 0.75m (**Diagram 3**). This was significantly

narrower than the 1.2m wheel span of a Mini Cooper S.

The only explanation I could see was the vehicle had left the road with a yaw to the direction of travel. However, to support this theory it was necessary to identify where the other two wheels left the road.

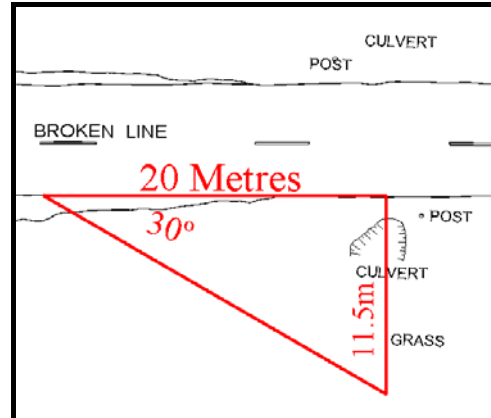
Diagram 2

Aside from the apparent illogical decision to drive on wet grass at high speed, I, as an engineer saw an inconsistency. A quick estimation considering the  $30^\circ$  angle and 20m distance put the car over 11m from the road not the 1.5m to 2m where it struck near the culvert head wall. (**Diagram 2**)

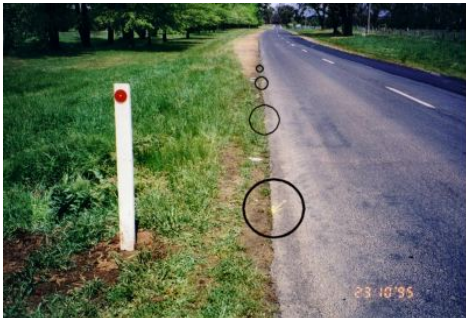
Photo 2

Looking at other photographs in greater depth revealed four yellow paint marks along the road shoulder **Photo 2**.

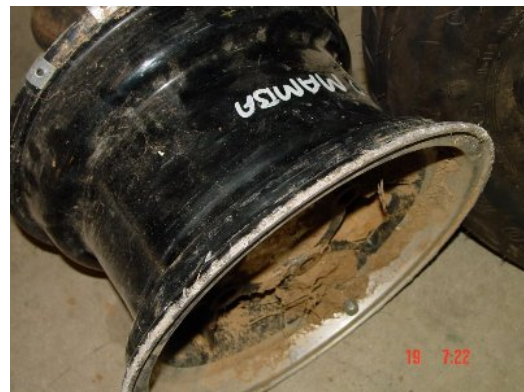
Photo 3

Of immediate interest however was the wheel shown in **Photo 3**. This left front wheel clearly shows dirt packed into it, and significant damage to the rim. These facts seem to suggest that the tyre may initially have deflated on the bitumen road surface before the left front wheel impacted with the drain leading from the culvert. The dirt packed in the wheel provided more evidence that the car was not travelling straight at the time of impact.

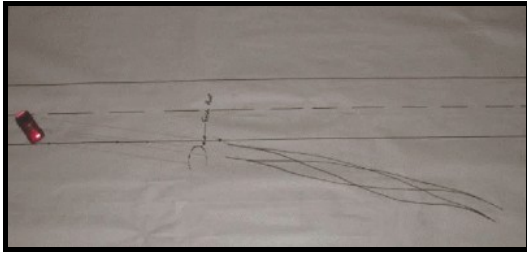
Photo 4

A snapshot of this animation is shown as **Photo 4**. While rather crude, it effectively galvanised all the facts known at that time. As a team we were now all confident of what had happened on the day, however our barrister still had to bring this information out of the plaintiff's witnesses.

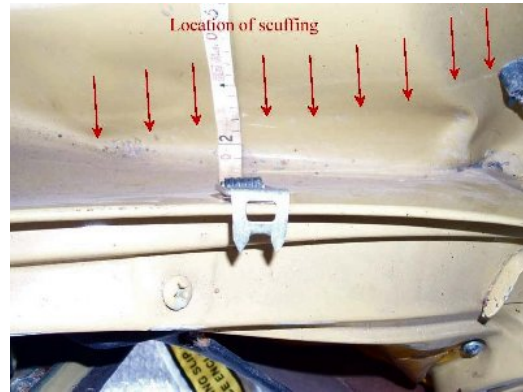
Photo 5

Far more helpful was the investigation by the Mechanical Engineer. While looking for modifications or problems that may have caused the Mini to lose control he discovered a vertical crease in the passenger side door. This crease shown in **Photo 5** was accompanied by white paint marks strongly suggesting

the vehicle had hit a standard white wooden guidepost. As these marks were inside folds in the door which had occurred as a result of the impact with the tree it was highly unlikely that this crease had been caused after the accident.

This evidence of the guidepost hitting the door fitted perfectly with our scenario and showed the culvert was delineated, contrary to the police opinion. It also explained why the police didn't notice the guidepost marks as they had assumed the vehicle to be travelling forward without yaw.

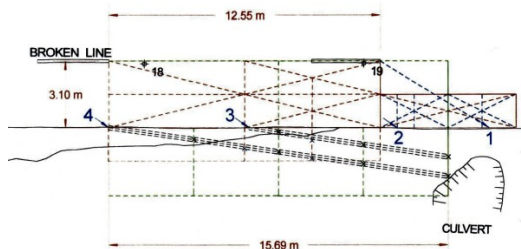
Diagram 4

As can be seen in **Diagram 4** each subdivision of the rectangles on the photograph are copied onto the plan view so measurements can easily be scaled.

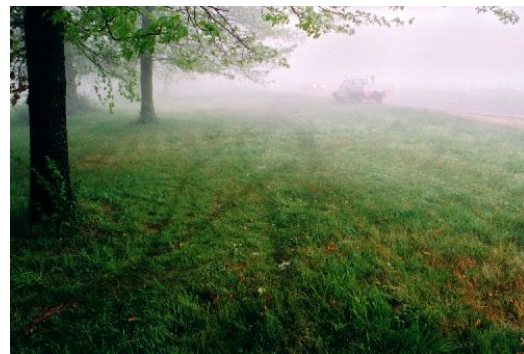
Photo 7

It was also apparent from the crossing tyre marks after the culvert that the car had rotated a full 360° in a clockwise direction before hitting the tree **Photo 7**.

*Photographic reconstruction* is a simple but very effective method of re-establishing tyre marks (as shown in **Photo 7**) by looking through a transparency of a photograph from the point the original photograph was taken.

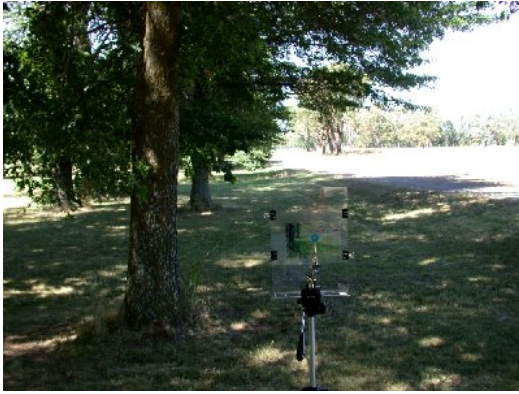
Photo 8

Once the transparency was correctly positioned as shown in **Photo 8** it was simply a matter of looking through the transparency and placing marks on the ground corresponding to the wheel marks. The results of this approach can be seen in **Photo 9**.

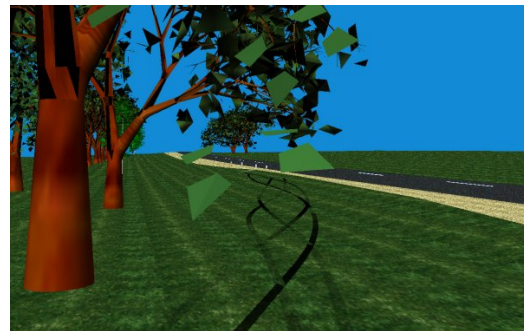
Photo 10

This model was more than just a graphic representation of the accident, as it dynamically modelled the impact of the vehicle with the culvert drain and illustrated the subsequent rotation on the grass surface before coming into contact with the tree (**Photo 10**).

The almost identical tyre marks generated demonstrated that the scenario we had developed was accurate and compelling evidence that a court would accept.
