IPWEAQ Central & North  
Queensland Branches Conference  
Winton 7 – 9 April 2005

Cost Effectiveness Of CCTV  
Inspection Of Underground Assets

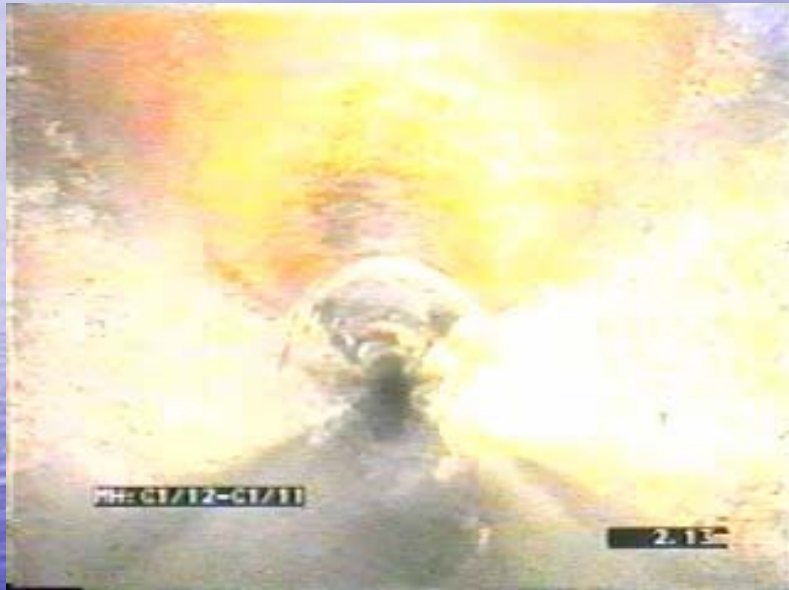
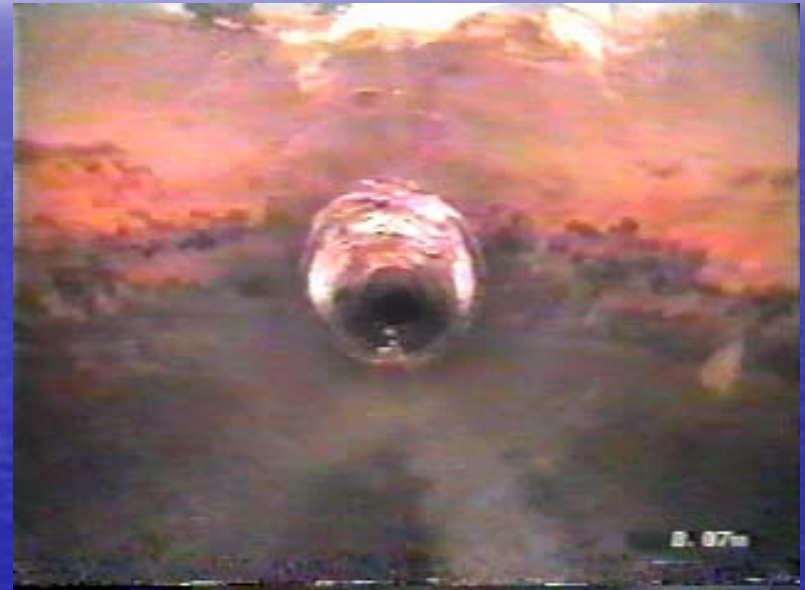
**So you don't end up with pipelines looking like this!**

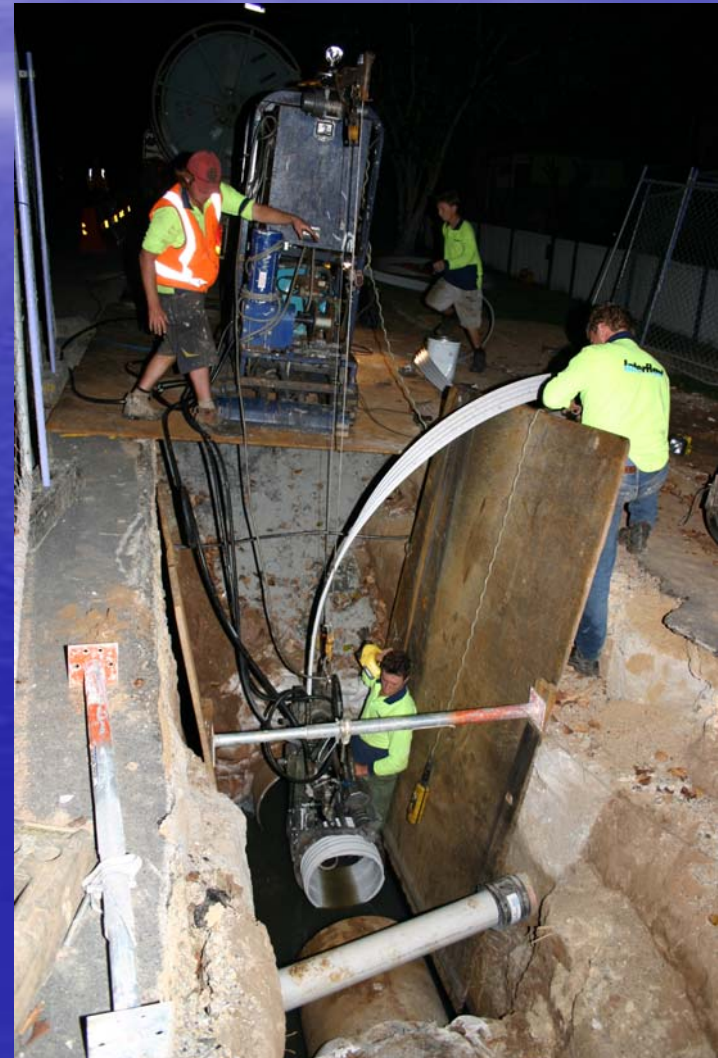
Brisbane Water –  
Jesmond Rd

600dia trunk sewer downstream  
of discharge manhole

Total failure resulting in a collapse  
of residential road

Large overflow of sewer into  
stormwater drain system

Emergency action required to  
repair pipeline

Rate to clean severely  
deteriorated AC pipe, install Rib  
Loc liner – Approx \$900p/m

Brisbane Water paid for initial  
emergency clean up, installing  
road plates, traffic control for 2  
weeks

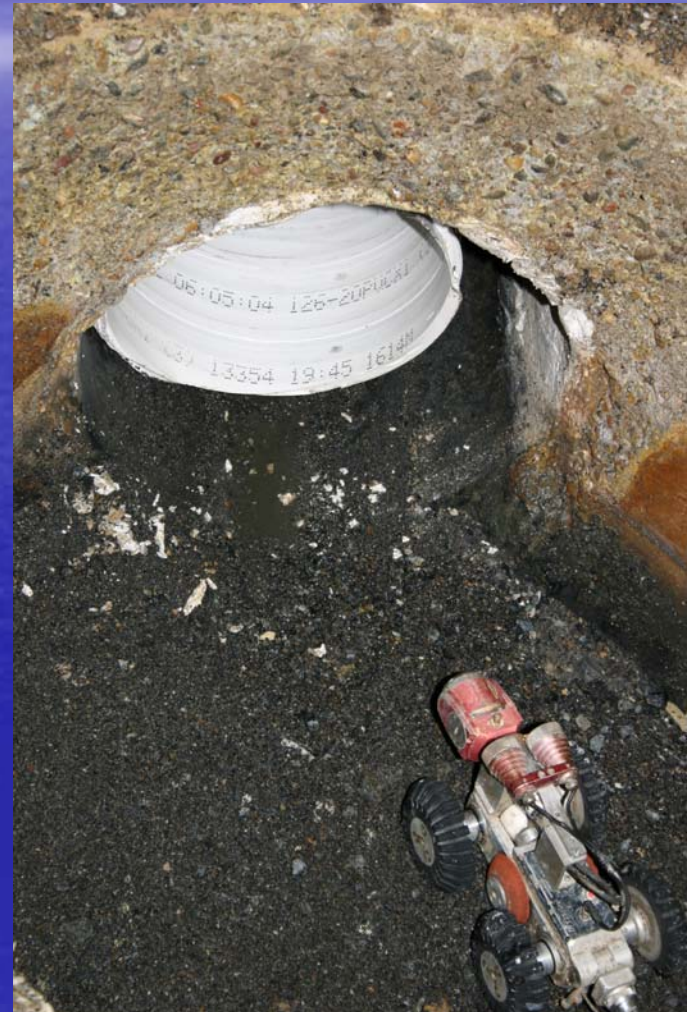
## Cairns Water – Lake St

600dia trunk sewer downstream  
of discharge manhole

Total failure resulting in a collapse  
of residential road

Large overflow of sewer into  
stormwater drain system

Emergency action required to  
repair pipeline

\$36,000 establishment costs  
Approx \$650p/m

Cairns Water paid for initial  
emergency clean up, traffic  
control

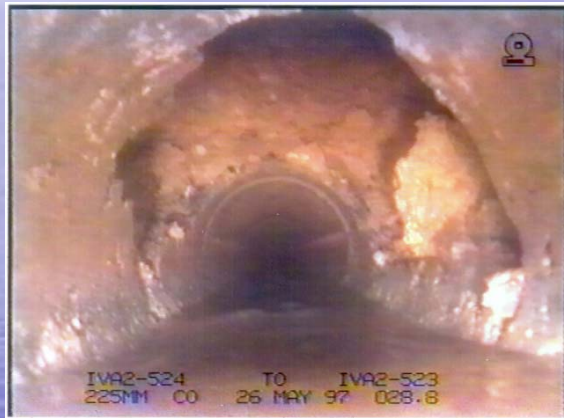
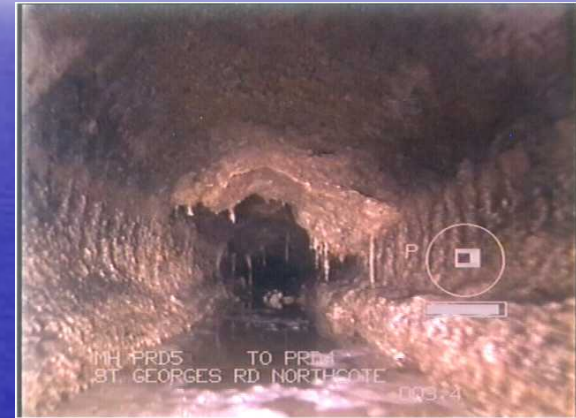
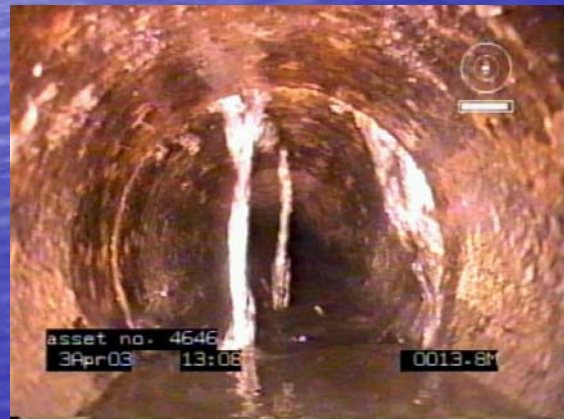
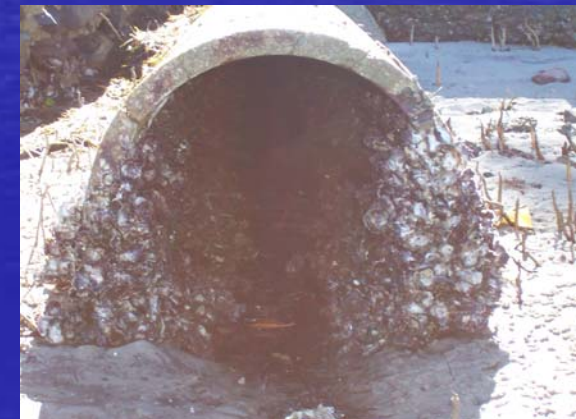
# Do your pipes look like these?

- Expanda PipeFaster installation with no waiting for curing or heat treatment.
- Smaller support vehicles leading to less traffic disruption and the ability to reline where other systems cannot.
- Quiet – no noisy boilers.
- Possible installation under live flow conditions.
- Efficient circular cross section with constant wall thickness – no “ballooning” in unsupported areas.
- An ‘as new’ pipe from manhole to manhole.
- No shrinkage after installation.
- All the pipes on the previous slide have been relined using the Expanda Pipe system with no pre lining repairs
