INTEGRATION OF SUSTAINABLE STORMWATER MANAGEMENT INTO COASTAL DEVELOPMENTS

Senior Engineer, Cardno MBK, Queensland Australia

Project Engineer, Cardno MBK, Queensland Australia

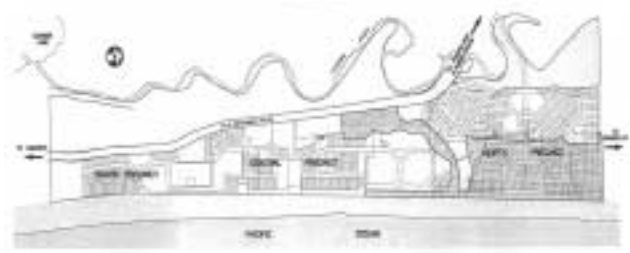
Figure 2: - Casuarina Beach

Casuarina Beach is effectively part of a large narrow peninsula, which runs from Cudgen Lake to Kingscliff. This peninsula is bounded on the eastern side by the Pacific Ocean, and on the west by Cudgen Creek (see Figure 2). While the creek has important ecological value, water quality has been adversely affected in the past by poor land use practices within the catchment, particularly in respect of disturbance of acid sulphate soils and farm erosion. Maintenance of at least existing conditions was therefore an important element. Protection of water quality within the Ocean at the doorstep of the project is also a critical issue for a high profile, high value beachfront community.

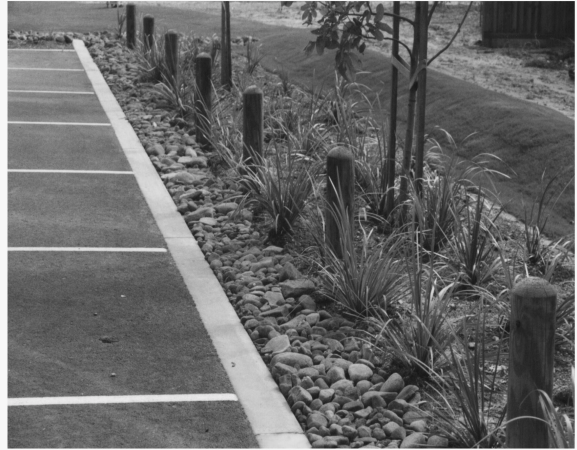
Figure 4: - Infiltration Trench Adjacent to Public Carpark

The construction of infiltration trenches for public parking areas to capture and treat runoff at source has also been utilised to reduce loads on the drainage network and downstream infiltration facilities (Figure 4).

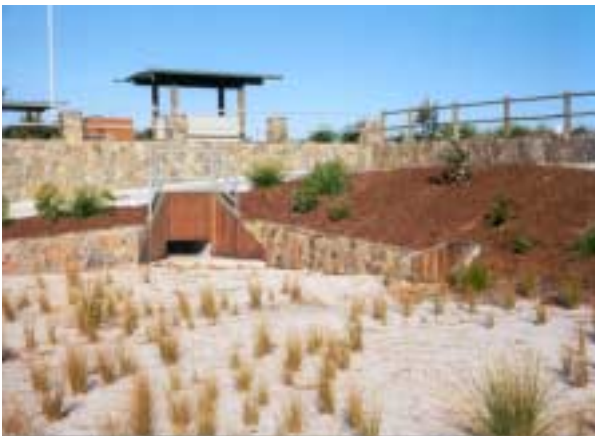
Figure 5: - Isolated Infiltration Basin in Central Precinct

The frontal swale which runs the full length of Casuarina Beach is intended to capture all runoff up to the 100 year Average Recurrence Interval, and, if required, to run it to specific westward flowing drainage paths constructed within the development. The drainage swales also operate as pathways, passive recreation and open space areas, thereby maximising developable area without compromising on engineering design standards. The swales incorporate a series of depressed infiltration basins to trap the 3-month event volume.

Infiltration basins were lightly vegetated using native dune grasses of local provenance, while the remainder of the drainage swale was revegetated as part of the overall dune rehabilitation program which was undertaken on site. The drainage swale was also integrated with a cycle/walkway which provides excellent access to the all parts of the development. Infiltration in this way therefore mimics the pre-development behaviour of the site, where surface runoff was a rarity rather than the norm. This achieves not only a good water quality outcome, but also maintains the status quo in respect of the hydrological functioning of the local area. In particular, it ensures that those groundwater flows which maintain the ecology of Cudgen Creek and surrounding wetlands are sustained.

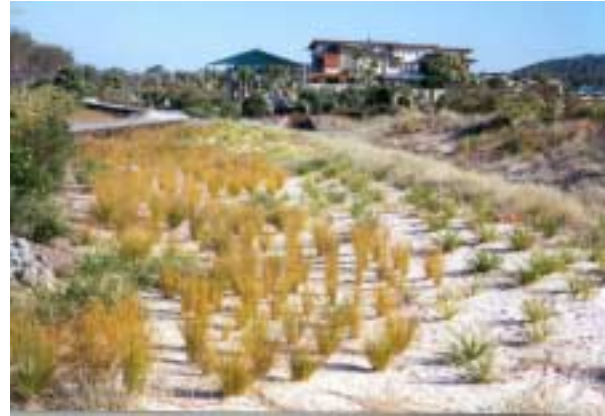
Figure 6: - Infiltration Basin in Frontal Swale.
(Note the boardwalk has been integrated into the swale area)
