Working Together To Manage The Bridge Risk

IPWEAQ
2003 STATE CONFERENCE
MACKAY

WORKING TOGETHER TO MANAGE THE BRIDGE RISK

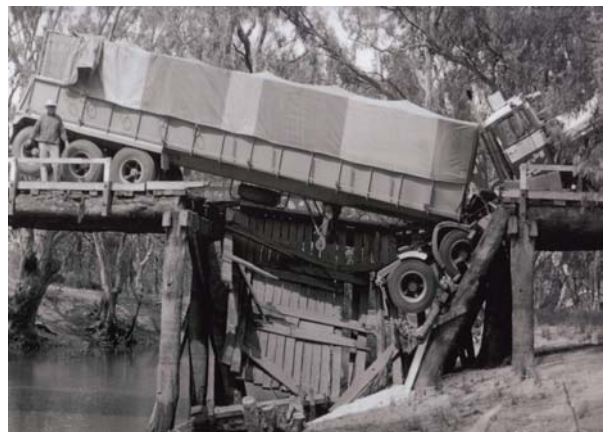
Figure 1 Failure of a timber bridge under load (interstate location).

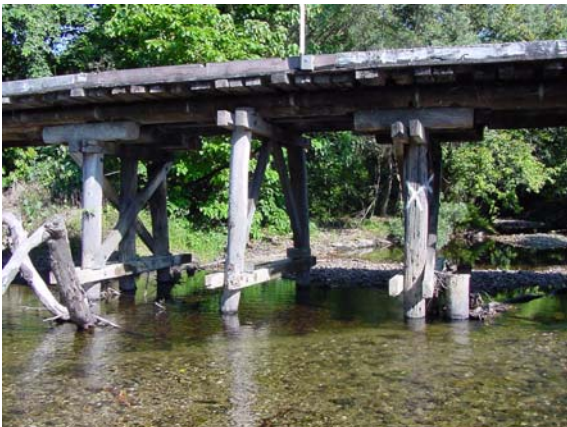
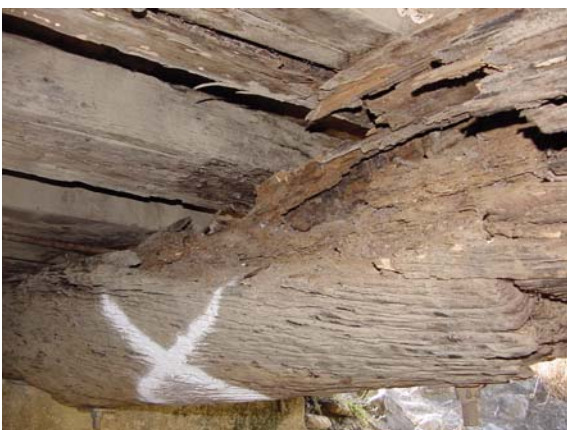
Figure 2 Bridges in need of risk management strategies.

With increased awareness of the bridge risk, the Douglas Shire Council responded by installing load limits and speed limits on bridges judged to be at risk (Figure 2, Figure 4). The resulting restrictions on the movement of goods had a negative economic impact in the community. It also encouraged freight operators to disregard the load limits in order for business to continue and consequentially diminishing the standing of the Council and the engineering profession.

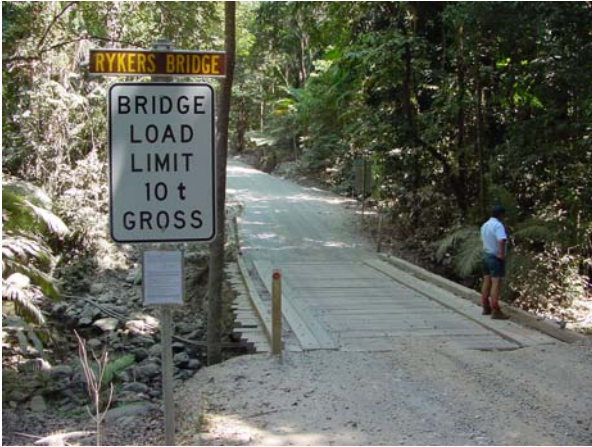
Figure 4 This load limited bridge has been replaced.

Deck condition was variable, exacerbated by a lack of scuppers to drain water. Two metal trough decks were severely rusted and some decks were 'flogging'. A number of the bridges had decks with large cantilevers and the girders clustered towards the centre raising concerns about failures to both the deck cantilevers and the external girders under eccentric wheel loads (Figure 3, Figure 4).

A total of five critical bridges have been replaced to date. One was a small girder bridge that was replaced with a baseless culvert due to the ecologically sensitive site (Figure 4). Four others have been replaced with prestressed concrete plank bridges with a cast-in-situ topping slab. These bridges are regularly submerged and thus a concrete wearing surface was adopted. One of the four bridges was a dual purpose bridge, supporting cane trains.

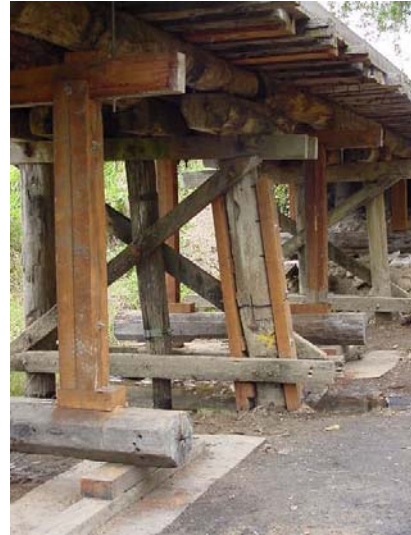
Figure 5 Temporary piers to strengthen deteriorated girders

Short-term repairs (Figure 5) were required on some bridges to allow cane trains to continue to utilise the bridges. These works were undertaken utilising Council crews.

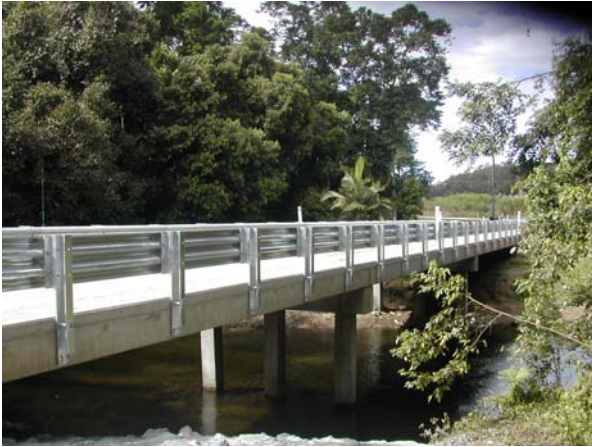
Figure 6 Typical replacement bridge

The replacement bridges (Figure 6) resulted in improved alignments, removal of load restrictions, marginal improvements in flood immunity, the incorporation of safety barriers and dramatic reductions in maintenance expenditure and risk.

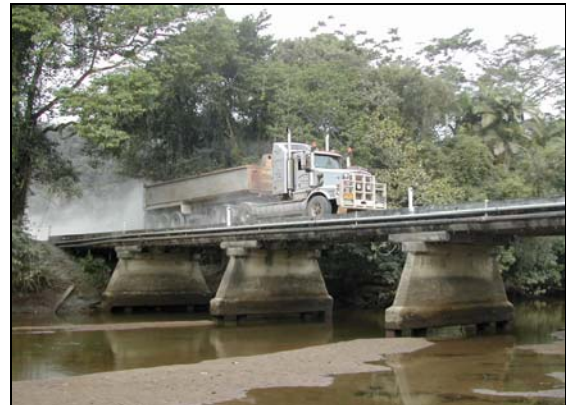
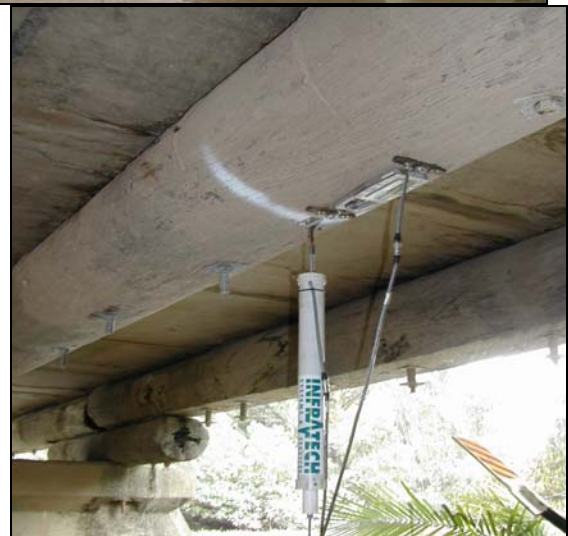
Figure 7 Test truck crossing bridge instrumented to measure deflection and strains.

The bridge had a restrictive load limit. Theoretical investigations confirmed the need for a load limit (Figure 3). A behavioural load test enabled the performance of this bridge to be further understood (Figure 7, Figure 8).

The testing demonstrated that the bridge was working strongly with additional load paths through the kerbs. The dynamic response was limited due to the restricted speeds possible on the bridge. This combined with the proven in-service track record of this bridge supported a strategy that involved keeping a load limit in place but implementing a permit system for legally loaded heavy vehicles that restricted speed and required central driving. Regular inspections and maintenance of the kerbs, deck and girders provides further support.
