WET OR DRY?

IPWEAQ
2003 STATE CONFERENCE
MACKAY

This paper describes an audit carried out for Gunnedah Shire Council in NSW, which evaluated alternative maintenance techniques for gravel roads, including the relative merits of wet or dry maintenance. The audit also evaluated techniques for gravel patching and resheeting. The merits of using innovative attachments such as serrated grader blades and “free-roll” rollers, were also evaluated.

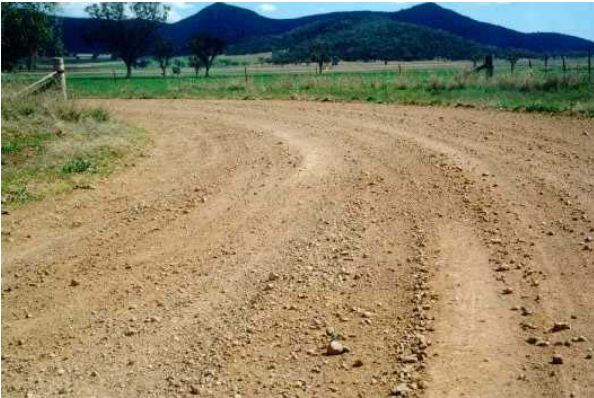
Photo1 – Bulga Road. Note the amount of loose material on the bend and the large rocks left after the fine material is lost either to the sides or as dust

The most widespread concern in Gunnedah Shire is dust and the large amounts of loose material formed as windrows between wheel tracks. These windrows were in some places 50 – 100mm deep. This loose material shows an accelerated rate of loss of gravel from the road as it is either being thrown off by the tyres or blown away as dust.

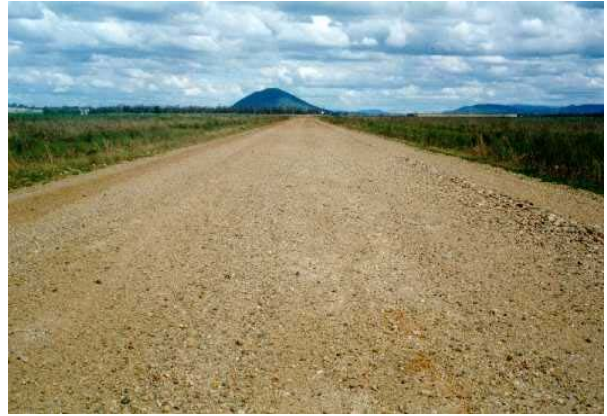
The width of the roads was also noted as a cause of concern, as some unsealed roads are up to 15 metres wide. This has come about from a combination of the gravel being pushed to the side by the passing traffic and the graders working beyond the original road width. This is a common problem with the dry grading technique and should be avoided because it increases the area of road to be maintained and encourages excessive speeds on straight roads.

Photo 2 - Mullaley – Boggabri Road Note the excessive width of the road which requires additional passes and frequent grading. There are also no guideposts to restrict the width to which the graders work.

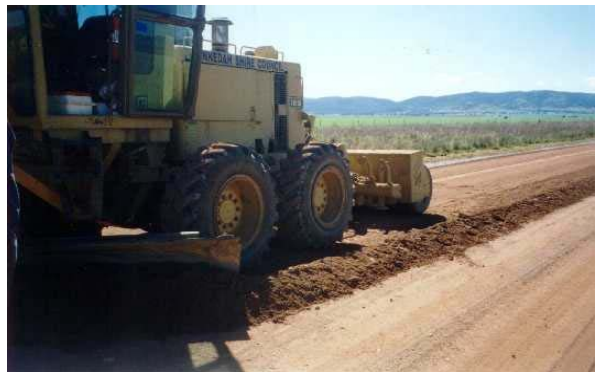
Photo 3 – Breeza - Piallawa Road. Grading in operation utilising the free-roll. Note the moisture in the gravel and the standing water in the table drain.

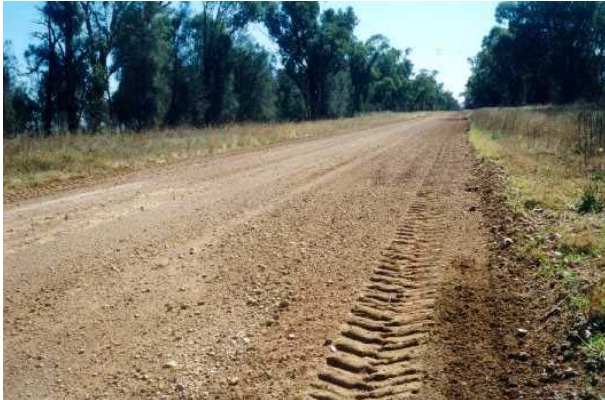
Despite the good moisture conditions at the time of the audit, the lack of a roller in most locations resulted in an excessive amount of loose material on the pavement as shown in Photo 4.

Photo 4 – Carroll - Breeza via Clifton Road. Shows the condition of the surface at the completion of grading. Note the amount of loose material on the surface and the windrow blocking flow to the table drain.

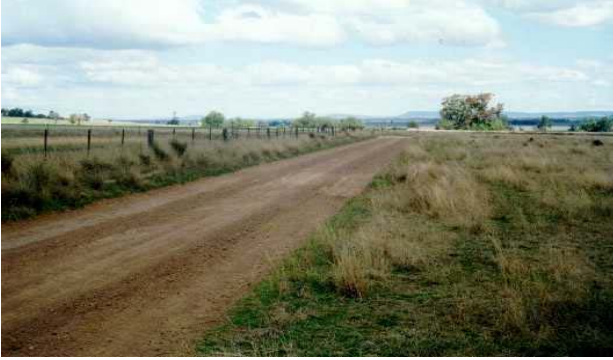
Photo 3.6 – Warboys Road. Previously

Photos 3.6 – 3.8 show the patching method being used by the contractors hired to carry out routine patching on the roads. The method observed was to run the material out of the truck, with thickness controlled by truck speed. Once spread, the material is rolled with the truck wheels. When possible this patching is done just ahead of the maintenance grader, which correctly shapes the patch. This method is effectively used as an interim measure to keep the road serviceable prior to the next resheeting cycle or to simply correct isolated weak spots in the pavement.

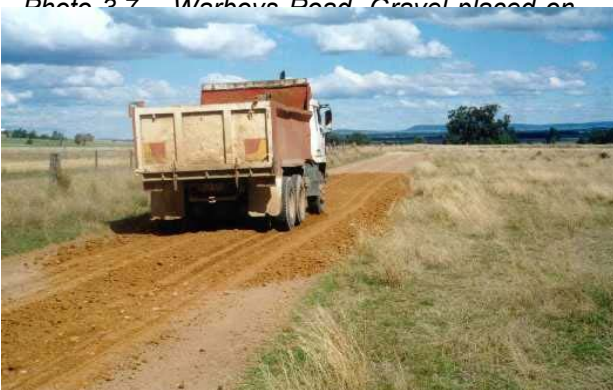
1. Control over the amount of gravel being placed on each patch is limited with either a half or full load being placed on each patch.
2. Poor compaction due to the variation in gravel thickness and the lack of a watercart and roller.

Photo 3.8 – Warboys Road. Gravel being rolled by the wheels of the empty truck

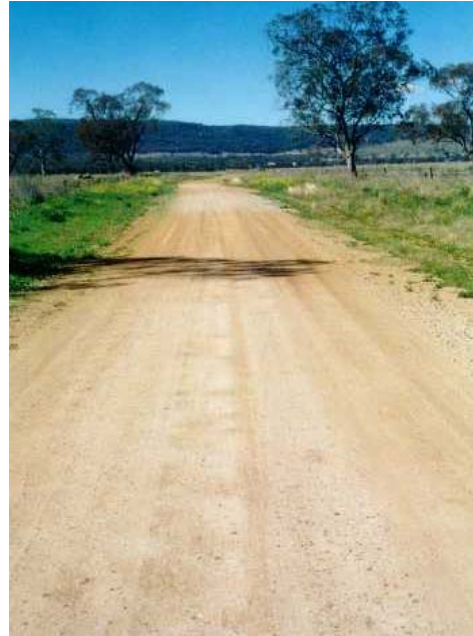
Photo 3.9 –Coochooona Road. Shows the use of patching to keep the road serviceable. Note the potholes due to a flat formation and lack of compaction at the time of placement

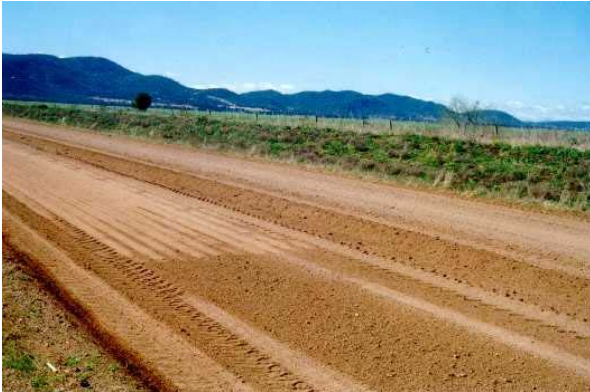
At the time of the audit, Council was trialling a Free-roll attachment (Photo 3.3) on one of the graders. Photo 3.10 shows that the roller produced a smoother and tighter crust on the surface which will hold together better under traffic and retain moisture longer. Closer examination of the surface showed that while the top was reasonably well compacted, the low moisture content prevented full compaction further down. Just the same, the

Photo 3.10 – Breeza – Piallawa Road. Shows the point at which the free-roll is applied to the graded road. Note the greatly improved surface due to this compactive effort

It was recommended that Council adopt a wet maintenance strategy, utilising a free-roll where suited to the materials and either a drawn or self-propelled vibrating roller where required.

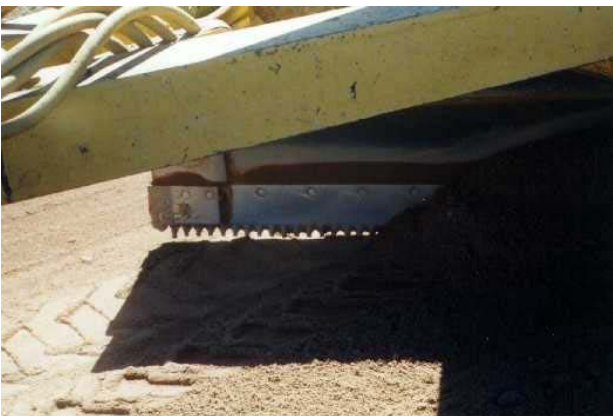
Most of the graders being used at the time of the audit had serrated cutting edges (or teeth) attached to the blade which scarify the surface, break up larger stones in the pavement and uniformly mix the material. All operators with these blades have been using them for some time and were extremely pleased with the results achieved. Photos 3.11 and 3.12 show the results achieved with the teeth as opposed to a conventional flat blade. As can be seen the conventional blade tends to smooth the cut surface, thus not allowing the backspread material to lock into the surface, while the teeth tend to scarify the surface providing a rough interface to tie the material in.

Photo 3.11 – Serrated Cutting Edges. Note the well mixed material and the ability of the teeth to lightly scarify the surface

It was also recommended that the use of serrated cutting edges on the grader blades should be retained.

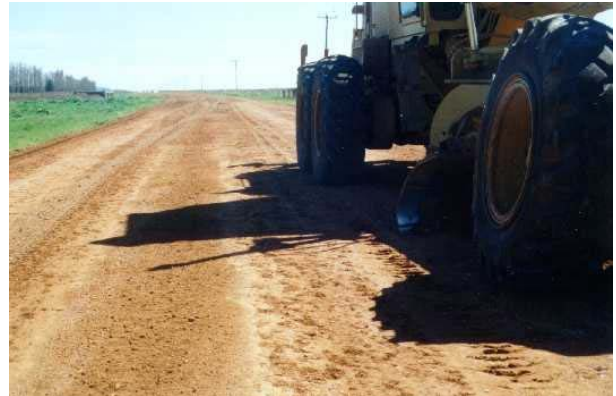
Photo 3.12 – Conventional Flat Blade. Note the smoothing of the surface which tends to occur and the poor mixing and spreading of the material. Also note the width being worked and relatively flat formation
