THE SEARCH FOR SUSTAINABLE BEACH PROTECTION FOR NOOSA MAIN BEACH

Rod Williams

Director- Works, Noosa Shire Council, Qld, Australia

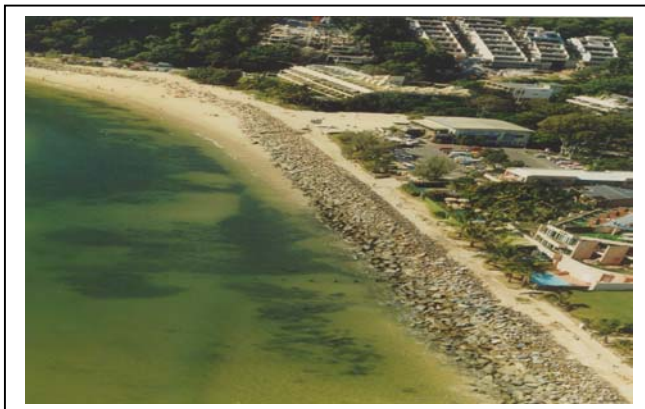
Severe erosion in 1988/89 resulted in loss of the beach back to the rock wall (refer figure 2). This led to a 3 year data collection study covering waves, currents, beach profiles etc to obtain information to assist in seeking a solution that “might” work.

Figure 2 - Eroded Beach April 1989

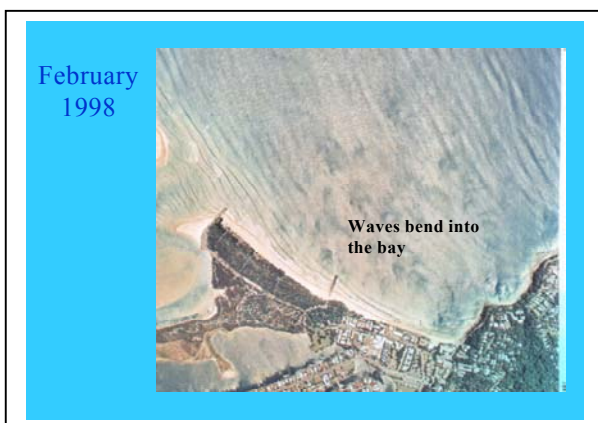
- a) Sand supply to the beach is mainly from the south and is irregular and unreliable. Large wave events are required to bring sand around the headlands into Laguna Bay.
- b) The rock wall alignment, which follows the property boundary alignment, is out of alignment with the waves. This is the direct cause of the erosion problem (refer Figure 3).

Figure 3 - Wave Crests are misaligned with the shoreline resulting in prevailing longshore currents to the west

- c) Strong currents are created westerly along the beach, mainly due to the misalignment and wave driven flows, causing sand to sweep past the Noosa Woods groyne.
- d) The amount of sand moving westwards exceeds by at least 40,000m³ per annum the amount being deposited on the beach.

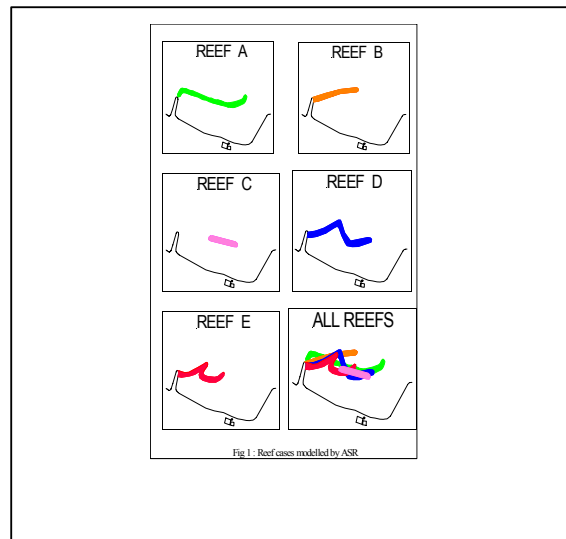
F

28 options for possible reefs were modelled with different shapes, positions and crest depths and narrowed down for short listing (Refer Figure 5).

The preferred option (Option E) was then subjected to very detailed modelling which ultimately involved more than 3,000 individual model simulations being undertaken.

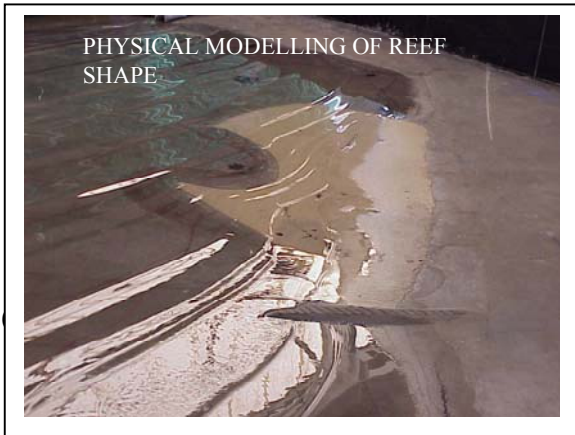
Rotation of the waves can be seen from a demonstration model - Figure 7.

Figure 7 - Wave rotation in a physical model

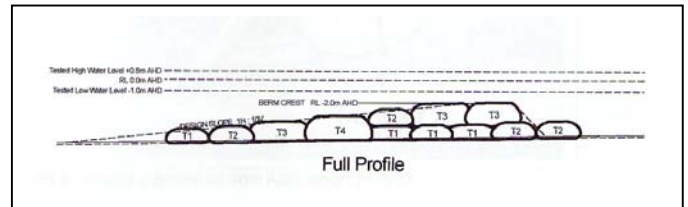
Crest height	RL-2.0m AHD (approx 1m below low tide)
Height	Up to approximately 3.5m
Width	
- Base	Up to 50m
- Crest	5m
Seaward Slope	1 in 10 to 1 in 12.5
Volume	Approximately 50,000m ³
Nourishment	
- Lower beach (from offshore)	70,000m ³
- Upper beach (from River)	50,000m ³
Estimated total project cost	Initially \$2.6 million Now \$4.2 million

The reef would be formed by Geocontainers as shown on figure 9.

Figure 9 - Reef Cross Section

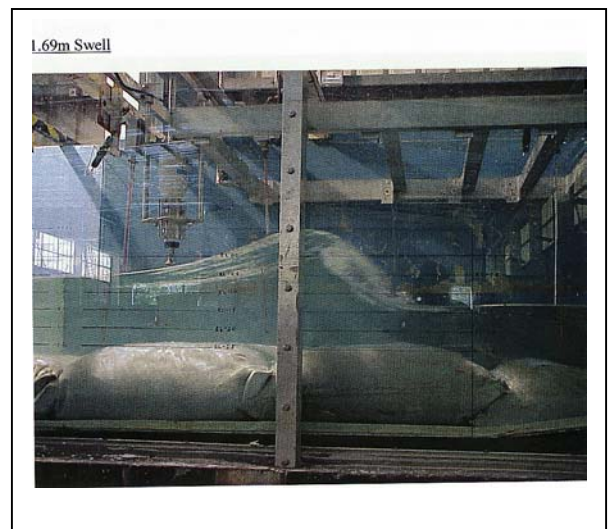
Physical modelling in a flume tank, in which scale models of the reef were placed and tested for varying wave conditions, was carried out at the Queensland Government Hydraulic Laboratories at Deagan.

A glass panel in the tank allowed wave breaking characteristics to be observed and measured - refer figure 10.

Figure 10 - Flume tank testing of wave breaking characteristics

Plunging waves were found to still occur during the tank testing for the reef at the original crest level (RL -2.0 m AHD - approximately 1m below low tide). Lowering of the crest by 0.5m to RL -2.5m AHD (approximately 1.5m below low tide) resulted in a change under most circumstances (up to 1.7m waves) to much safer spilling waves, breaking onto an increased water depth (approx. 1m). Lowering of the crest was found to be necessary.
