# ASSISTING YOUR BARRISTER - ACCIDENT RECONSTRUCTION CASE STUDY

John Boyd, [jboyd@orange.nsw.gov.au](mailto:jboyd@orange.nsw.gov.au)  
Acting Director Technical Service , Orange City Council,  
NSW, Australia

This case study discusses how a defence was developed against a civil claim by assessing seven year old evidence to reconstruct the circumstances of a motor vehicle accident. Our reconstruction of events differed markedly from the account presented by the investigating police officer and that proposed by the plaintiff.

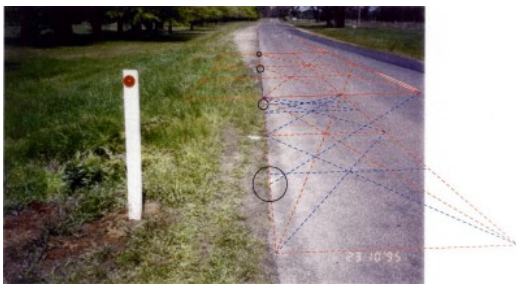
Photo 6

While the plaintiff offered an “expert” to say that measurements could not be taken from a single photograph, Mr George demonstrated this not to be the case by using a photogrammetry technique referred to as *perspective grid analysis*. In simple terms if it is possible to define a rectangle on a plane in a photograph, subdividing or extending this rectangle can allow reasonable measurements to be made. **Photo 6** illustrates how this was achieved knowing; 1) the straight centre line of the road is parallel to the road edge, 2) the distance between centre line markings and 3) the lane width, which was measured at the time of the accident.
